**3Dscans of underground fortifications in Maastricht,
Leander GOOR, Cursor AM, NL**

3D Visual Inspection Platform

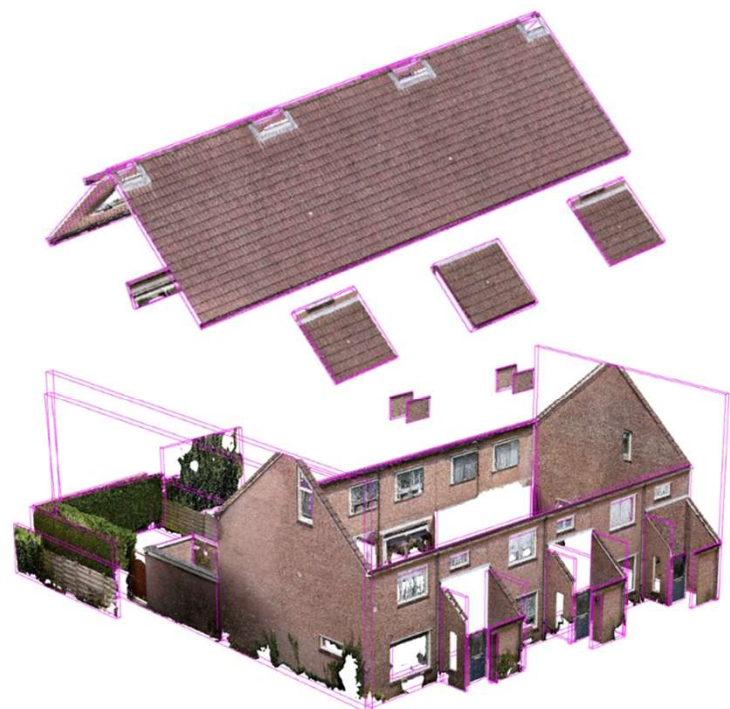
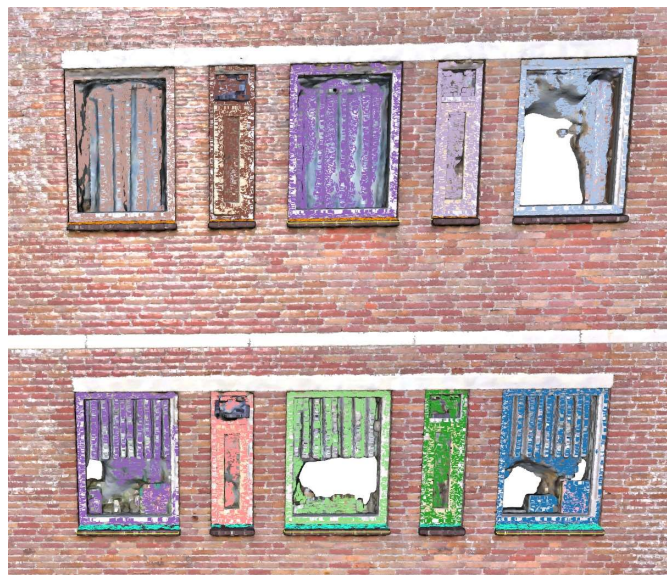
BAM Wonen – Artificial Intelligence as a Service

Type	Class	Width	Height	Surface m2	BottomLeft	TopLeft	TopRight	BottomRight	
0	other	A	0.662	0.574	0,39126004562046	[9.3363114 11.292	[-9.33566911 11.292	[-8.85736133 11.777	[8.85802336 11.776
1	door	F	0.978	2.083	2,03727380919228	[15.79572257 36.25	[15.76053244 36.28	[16.45773114 36.97	[16.49292127 36.93
2	window	J	1.95	0.992	1,93427977115089	[8.73420526 10.76	[8.72454152 10.752	[7.43849669 12.217	[7.44816043 12.226
3	window	K	1.827	1.55	2,83072705847883	[5.45403544 -0.750	[5.46024681 -0.756	[6.75433276 0.532	[6.74812139 0.538
4	window	Ks	1.826	1.564	2,85564981301601	[5.14041071 -1.078	[5.15538064 -1.084	[6.44911379 0.204	[6.44314386 0.210
5	window	C	0.924	0.535	0,4942425046110	[15.17780256 8.943	[15.17919288 8.942	[15.83405385 9.594	[15.83267354 9.592
6	window	H	1.38	2.15	2,96552391708528	[15.19845285 8.922	[15.20509109 8.915	[16.18252084 9.886	[16.1758826 9.896
7	window	C	0.925	0.528	0,48821993069458	[16.94044423 10.68	[16.94170324 10.68	[17.59697212 11.33	[17.59571311 11.33

8	window	I	1.39	2.293	3,1673891464314	[16.62699538 10.33	[16.63158255 10.33	[17.6166636 11.314	[17.61207643 11.31
9	window	Ks	1.826	1.597	2,91619963006129	[18.38057461 12.09	[18.38595775 12.06	[19.68008245 13.37	[19.67469932 13.38
10	window	K	1.826	1.561	2,85053418307985	[18.70846477 12.41	[18.71171912 12.41	[20.005637 13.699	[20.00338264 13.70
11	window	K	1.826	1.613	2,94428981518393	[20.76529349 14.48	[20.77318165 14.47	[22.06685554 15.76	[22.05898738 15.77
12	window	Ks	1.826	1.523	2,78125272828023	[20.45713251 14.16	[20.462486 14.163	[21.75663905 15.45	[21.75128557 15.45
13	window	C	0.925	0.542	0,50148389361425	[22.84743988 16.54	[22.84813212 16.54	[23.50380341 17.20	[23.50311117 17.20
14	window	Is	1.374	2.983	395,027,077,051,66	[22.85162191 16.54	[22.86212516 16.53	[23.8362368 17.504	[23.82573355 17.51
15	window	C	0.926	0.533	0,49323554058665	[7.53014866 1.315	[7.53122751 1.314	[8.18730767 1.967	[8.18622702 1.968

16	window	C	0.925	0.55	0,50858942144302	[24.589308 18.310	[24.59097598 18.30	[25.24626156 18.96	[25.24459358 18.96
17	window	Hs	1.374	2.097	2,88126092473084	[24.29365233 17.97	[24.29953509 17.97	[25.27326834 18.93	[25.26738658 18.94
