# European Military Heritage: Henri Alexis Brialmont From Belgium to Romania

**AUTHOR:** Andrei Vlădescu

**DEPARTMENT:** University of Bologna: Science for Cultural Heritage

### **FORT 7 WILRIJK CAMPAIGN:**

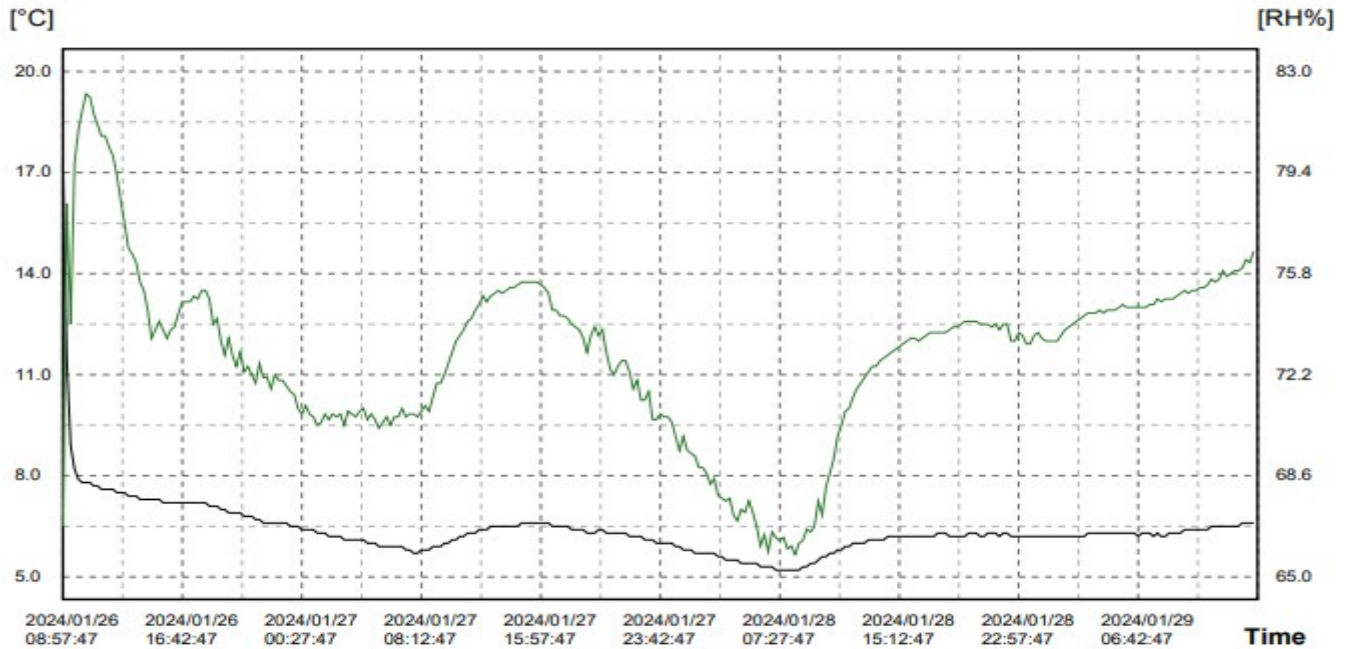
Fig. 2. Recorded Humidity and Temperature data over the period of 4 days.

During the campaign the campaign 2 data loggers have been used to record the Relative Humidity (RH) and the Temperature (°C), the First data logger has been placed in the interior, ground floor of the fortress and left to monitor the data over a period of 4 days. The second data logger was moved throughout the fortress in order to register the Relative Humidity. Additionally a Resistance Meters (Pin Type Moisture Meter) has been used to record the Moisture inside the Fort. A soil pH, Temperature and Moisture measure was also planned directly next to the walls of the fort, but this was cancelled due to the lack of relevance of the data, the pH of the rainwater is generally mildly acidic, and the Soil acidity of Antwerp is known to be on average below 5.5, based on the European Commission's Institute of Environment and Sustainability, as such an acidic environment is expected. The only relevant data would have been the moisture content in the soil but due to the weather conditions it would have made little sense to collect soil moisture data.

As observed in the Table, the Mobile Logger is on average 7.92°C warmer and has a relative humidity that is 22.58% lower than that of the stationary one. The mobile logger has been used throughout the Fort to map the micro-climate of the inner keep. Considering the new designation of the Fort as a Bat Hibernation Natural Reservation, it was important to observe under which conditions certain parts of the fort offer suitable hibernation spots for the bats. Most of the readings from the mobile logger have been collected from the 1<sup>st</sup> floor of the main inner keep of the fort, which have been noted for hosting hibernating bats in the past years, although in recent times their number kept decreasing, this year, no Bat has been spotted on this floor.

Considering these significant differences, we can expect a reading error of  $\pm 2-4$  °C (with an internal machine error of about 0.50-1.00 °C).

Even so judging by the data collected and its difference, it can be noted that the ground floor proves to be a much suitable environment for the bats, providing a low temperature as well as a generally high humidity. On the other hand, the 1<sup>st</sup> floor of the fort has significantly less RH, even in the scenario in which temperatures are actually lower and the average RH of the 1<sup>st</sup> floor has an error of -10%, which would still be lower by 10-20% than the Ground Floor. This difference in temperature can only be explained by the water infiltration into the structure, with the ground and upmost top levels of the fort providing the lowest temperatures with highest RH (due to the earthwork present on the roof of the fort), while the mid-point between these extremities (in our case the 1<sup>st</sup> floor) provides a more temperate micro climate with generally less humidity. The Moisture Meter data further supports this theory with a general reading of 14-23% moisture content in the walls of the main corridors of the 1<sup>st</sup> floor, an average of 20-26% moisture content in the walls of the rooms oriented to the outer side of the Fort, and lastly an average of 26-40% moisture content was in the area of the room's windows (most of the 30-40% reading have been detected in the higher parts of the walls, with some readings of 16-26% in the lower parts).

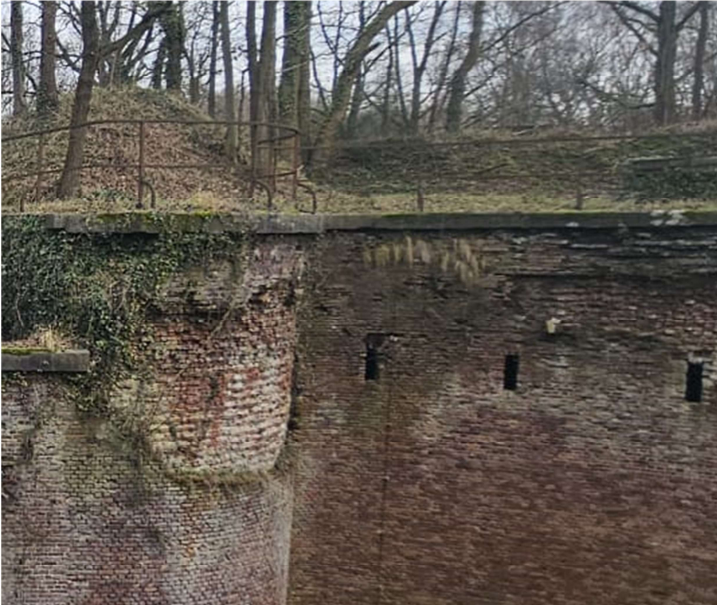
sand and other additives of choice. On it's own this doesn't mean anything. But in the context of low pH water and salts carried by the water from the soil into the walls, the Calcium Carbonate can in fact transform into Gypsums and start to "leach out" causing loose of aggregation of the mortar as well as plastic deformation, which in time would mean that the bricks will start to detach from the walls. This case can be seen in the Fort in areas which had a draining system mounted.

**Brick Layer Detached Due to High Moisture Level**

*Fig. 4. Detached Brick Layers caused by the leaching of mortar from the wall*

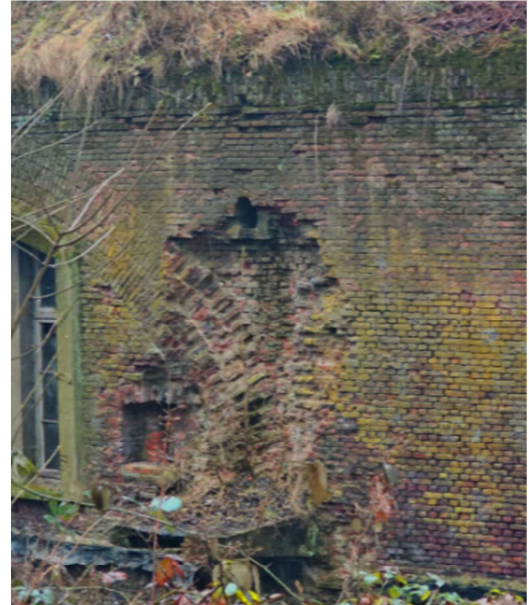
**Damaged Amplified by Water Capilarity Infiltration**

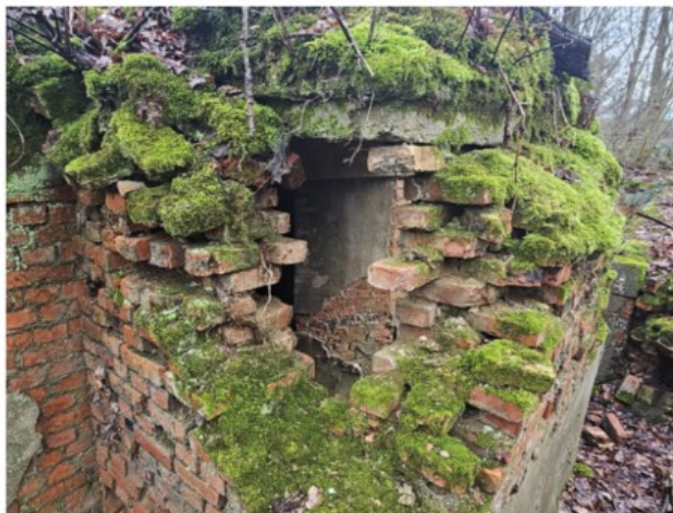
And this degree of damage could be also seen in the German "modernized" additions brought to the fort. Although regarding these additions it must be noted that these fortifications were built in a rushed emergency regime, with little care for the long term conservation or integrity.

**Deteriorated German Additions to the Fort**

*Fig. 5. Detached Brick Section and Moisture Saturated Area of the German Fortification*

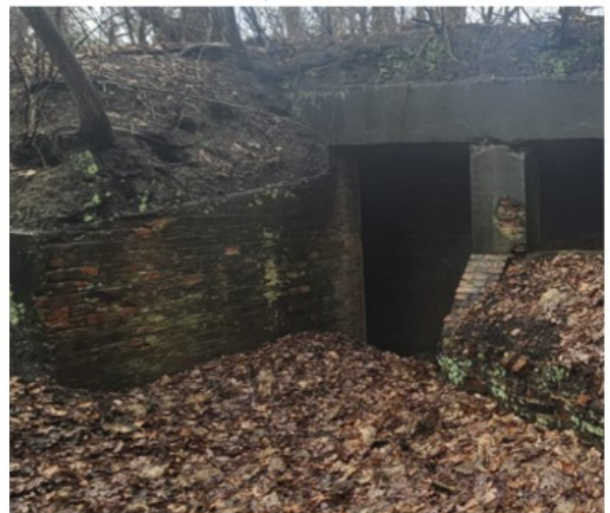
**Water Damage And Biocolonisation sponsored by Excessive Wetness/dampness of the Material**

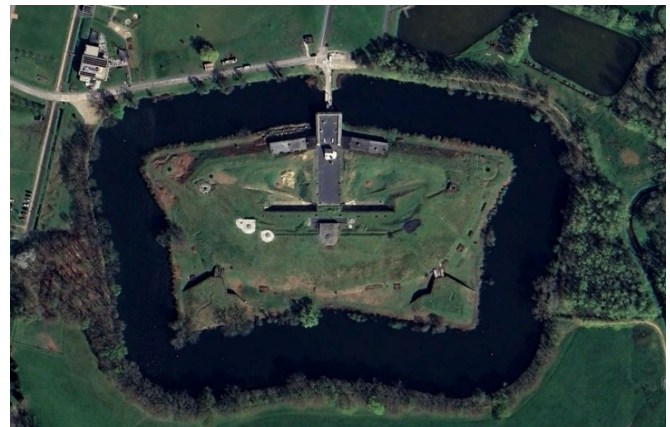
*Fig.6. (Google Earth)Satellite view of the late 1880s*

*early 1900s Fortification and surrounding ditch.*

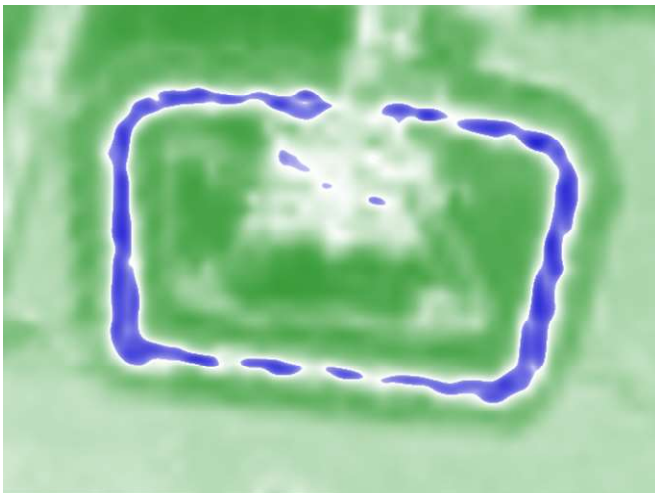
Fig.8. (Sentinel-2)NDWI view of the Fort Breendonk

Utilising the Normalised Difference Water Index (NDWI), a map of the relative distribution of water content can be created (blue areas are water bodies, green are vegetation and white areas are areas with a degree of moisture content (usually structures, but can be agricultural fields or streets as well)).

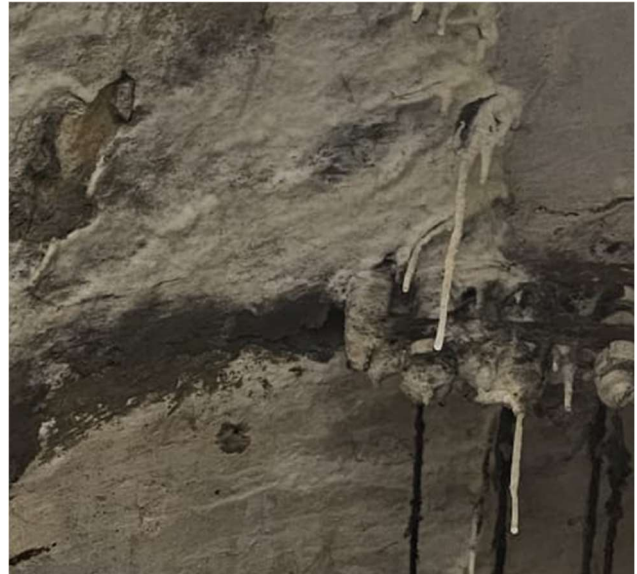
Fig.10. Salt deposition after re-crystallisation

This is a normal occurrence in areas that do not have a humid microclimate but the general climate of the area can be rainy or humid, it is also a normal occurrence in areas close to large bodies of water, and in our case, the fort acts like an island in the middle of an area that has shallow phreatic water level. This problem is slightly accentuated by the sunken profile of the fort, being in closer proximity to the

phreatic water level, thus transporting more salts into the structure of the fort.

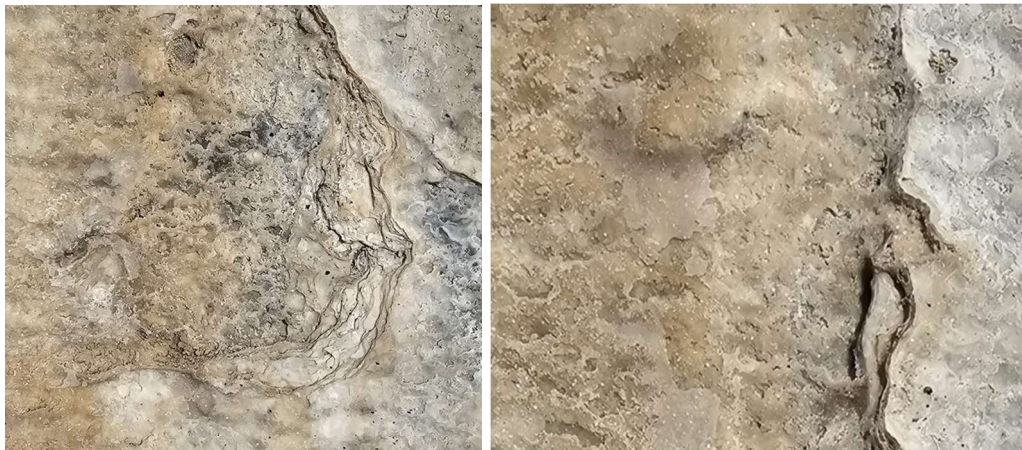
*Fig.12. Salt blasting close-up.*

Entering into a more in-depth analysis of the source and morphology of the salts would be beyond the scope of this article, but it is noted, that this exact type of deteriorations can be found in the Bucharest Fortifications. More than that, due to “sunken” profile of the main fortification, many of the Bucharest Fortifications suffer from flooding of the main structure, which makes them inaccessible and hazardous. Furthermore, due to flooding, a lot of salt solubilised salts are transported into the structure of the Forts.
